PELLA VINYL EAST PRODUCT TROUBLE SHOOTING GUIDE

Encompass by Pella™ 2/2008 - Current, ThermaStar by Pella® 2003 - 01/2022 and Centera by Pella™ 2/2007 - 2/2012

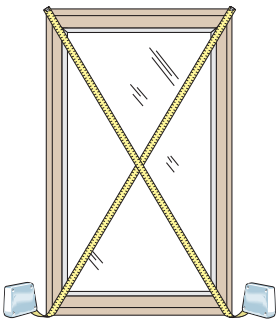
ISSUE: Sash to frame reveal is not even, when viewed from exterior.

ANSWER 1: Check unit for square by measuring diagonals. Open sash and check operating hardware (including roto, hinges and pivot arms) for damage. Replace hardware as needed.

ANSWER 2: Remove and reinstall sash to correct reveal – check diagonals of entire unit if needed. If the frame is out of square, installer needs to be involved. (Discuss with your manager).

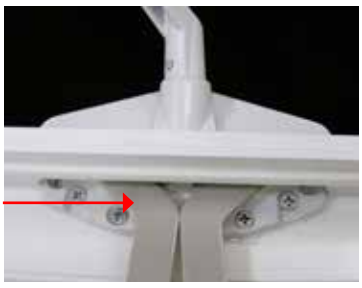
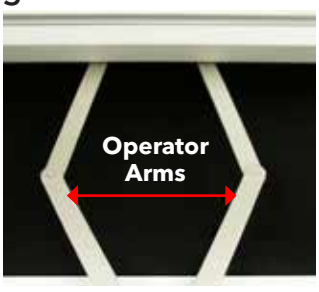
ISSUE: Roto operator is broken or gears are stripped.

ANSWER: Replace roto operator.

See PERL for service instruction "Roto Operator Replacement"

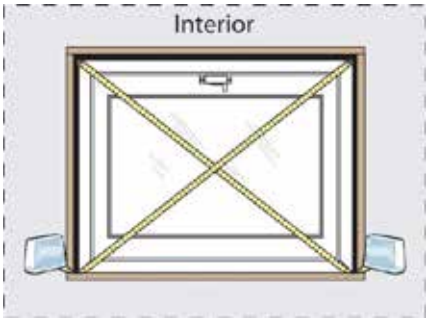
ISSUE: Frame installed out of square.

ANSWER: Check diagonals of unit they need to be within an 1/8" of each other.

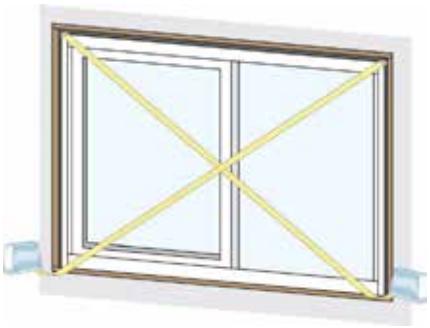
ISSUE: Frame or venting sash slightly out of square causing gap at checkrail.

ANSWER: Replace rollers in the housing on one end of the venting sash.

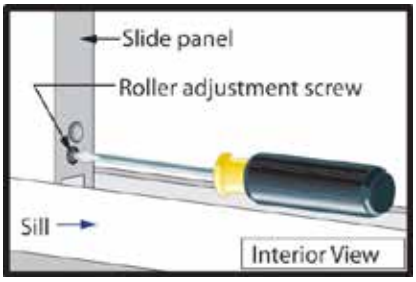
ISSUE: Lock does not align with keeper/strike correctly.

ANSWER 1: Adjust the "throw"/"reach" of the mortise lock.
ANSWER 2: Replace or adjust keeper/strike.
ANSWER 3: Adjust panel rollers.

See PERL for service instruction "Lock Adjustment", "Keeper Replacement" or "Roller Adjustment"

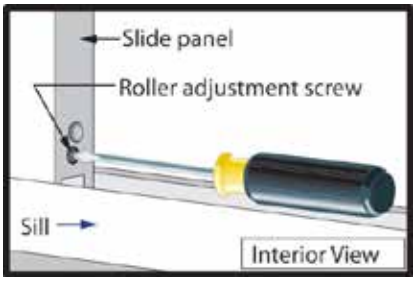
ISSUE: Dirt and debris on the sill track

ANSWER: Use brush, broom or vacuum to clean track area. Lubricate sill with dry silicone spray or similar product.

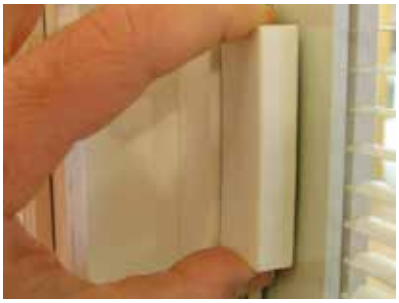
ISSUE: Top handle (tilt) and the blind out of sync.

ANSWER: Slide the handle all the way to the bottom of the guide track. While sliding handle down; push through any resistance at the top as this will reset the handle for proper tilt operation.

See PERL for service instruction "Blinds Between the Glass-Handle and Operator Track Replacement"

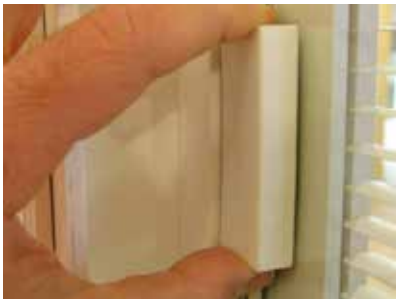
ISSUE: Blind will not lower evenly (one side tips).

ANSWER: Using the tilt operator, ensure the slats are in the open position, then raise and lower the blind a few times.

See PERL for "Vinyl Patio Door Blinds Operation Guidelines"
